## DC ground fault locating under difficult conditions An AC coupling tale...

### CASE STUDY

## DC ground fault locating in the presence of unwanted AC coupling

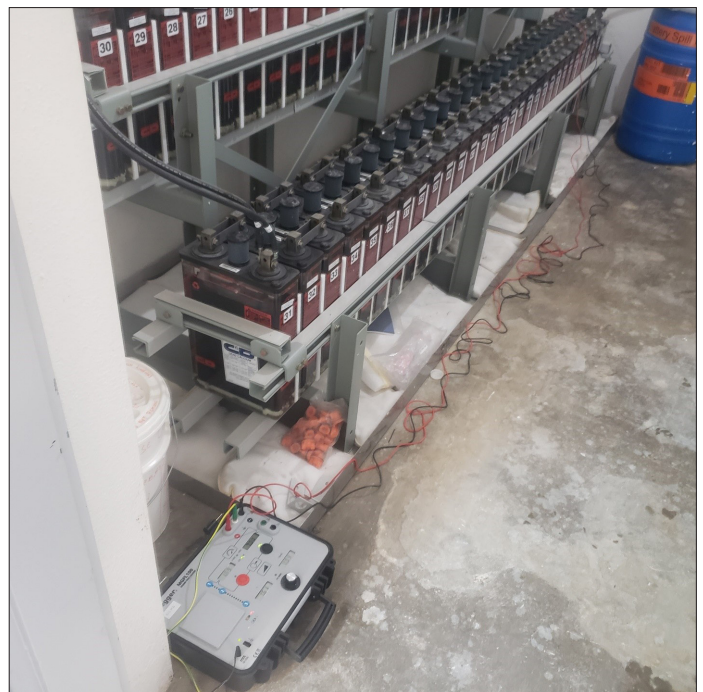
- TVA had used the Megger BGFT and a competitor's unit and traced the fault to the battery charger. They replaced the battery charger, and the fault did not go away.
- Megger assisted with the investigation. We placed a Megger MGFL100 on the string, and it did verify the presence of a negative ground fault (Figure 1).

Figure 1: the Megger MGFL confirming a negative ground fault on the battery string

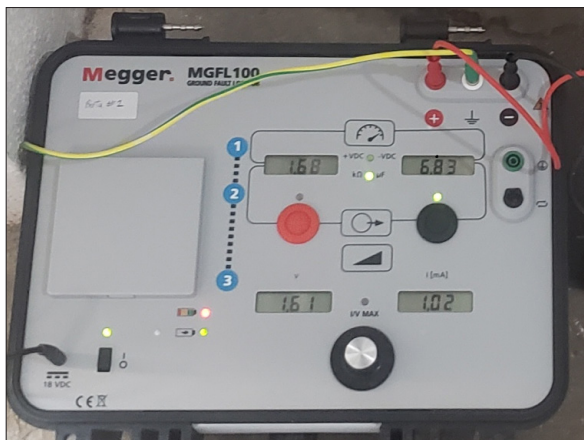
- With the MGFL100, we injected current and found the resistive value of the ground fault to be about 1.7K. The MGFL100 also showed the leakage capacitance to be about 7uF.

Figure 2: the Megger MGFL test results

- Meanwhile, we observed that the current, resistance, and capacitance values were all unstable.
- The fault current was present on the negative battery cable. The investigating team performed tracing and found that there was also current on the positive buss. Once again, none of these readings were stable.
- Knowing the MGFL100 transmitter will output a stable low-frequency AC current, the unstable measurement indicated an alternate low-frequency AC presence in the system.
- After turning off the transmitter, the MGFL100 receiver still measured an AC current on the positive buss. Therefore, there was AC coupling over to the DC.
