## DC ground fault locating under difficult conditions An AC coupling tale...

## DC ground fault locating in the presence of unwanted AC coupling

Tennessee Valley Authority (TVA), located in the Southeastern region of the United States, generously supplied this case study.

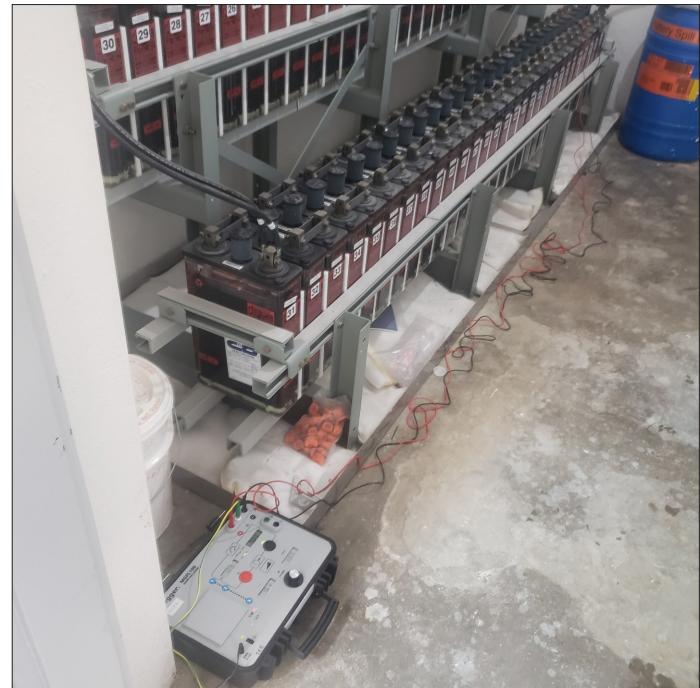
- TVA had used the Megger BGFT and a competitor's unit and traced the fault to the battery charger. They replaced the battery charger, and the fault did not go away.
- Megger assisted with the investigation. We placed a Megger MGFL100 on the string, and it did verify the presence of a negative ground fault (Figure 1).

Figure 1: the Megger MGFL confirming a negative ground fault on the battery string

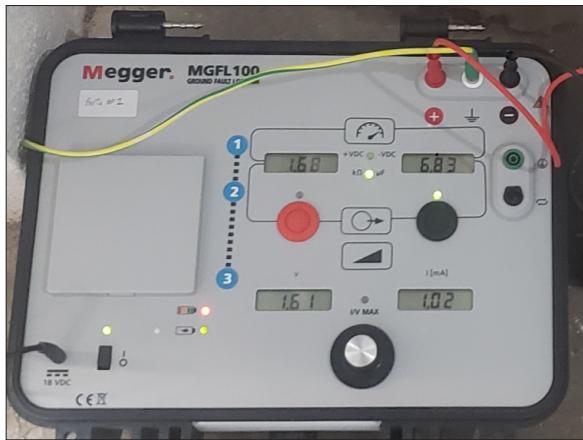
- With the MGFL100, we injected current and found the resistive value of the ground fault to be about 1.7K. The MGFL100 also showed the leakage capacitance to be about 7uF.

Figure 2: the Megger MGFL test results

- Meanwhile, we observed that the current, resistance, and capacitance values were all unstable.
- The fault current was present on the negative battery cable. The investigating team performed tracing and found that there was also current on the positive buss. Once again, none of these readings were stable.
- Knowing the MGFL100 transmitter will output a stable low-frequency AC current, the unstable measurement indicated an alternate low-frequency AC presence in the system.
- After turning off the transmitter, the MGFL100 receiver still measured an AC current on the positive buss. Therefore, there was AC coupling over to the DC.
