## Staying Compliant with NFPA 70B Standards GLOBAL TEST SUPPLY

### Key Considerations for Businesses

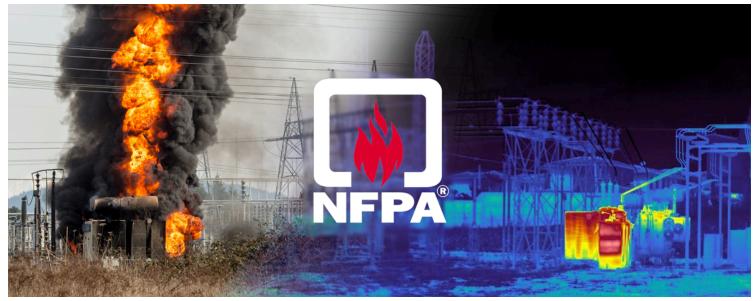
Figure 1: Thermal Imaging in Industrial Plant for Prevention

One of the primary updates in the 2023 NFPA 70B standards is the emphasis on accurate thermal imaging. Companies now need access to thermal imaging cameras that can precisely measure the  $\Delta T$  (temperature differential) of similar electrical components under similar loading conditions. This capability is essential for identifying potential hot spots, which could indicate underlying issues such as loose connections, overloaded circuits, or insulation failures.
