## Ground fault tracing: CT magnetization

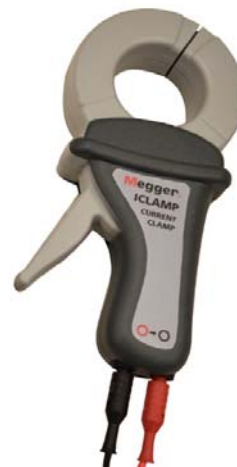
The mini active CT for the MGFL100 uses a flux gate technology, allowing a gap in the core. This also greatly reduces magnetization effects.

When tracing low level AC signals or pulses, the larger and purer the CT core, the higher its permeability and the more sensitive the CT will be. This makes the CT better at measuring these low currents used to trace faults. However, this also makes such a core more susceptible to magnetization. The MGFL100 CT is very sensitive but will not have any significant magnetization. This is because the core is made of a mu-metal compound. This core maintains high permeability but is far less prone to magnetization. If it is placed on an energised DC line, it can still easily be removed without any damage.
