Ground fault tracing: CT magnetization

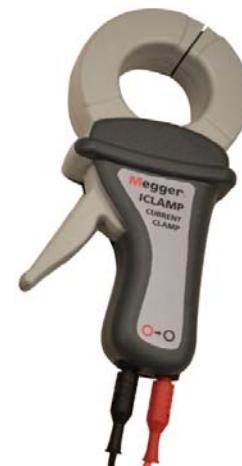
The MGFL100 CT is very sensitive but will not have any significant magnetization. This is because the core is made of a mu-metal compound. This core maintains high permeability but is far less prone to magnetization. If it is placed on an energised DC line, it can still easily be removed without any damage.

The mini active CT for the MGFL100 uses a flux gate technology, allowing a gap in the core. This also greatly reduces magnetization effects.

Using these current clamps will eliminate magnetization issues due to DC current.
