## DC ground fault locating under difficult conditions An AC coupling tale...

### CASE STUDY

## DC ground fault locating in the presence of unwanted AC coupling

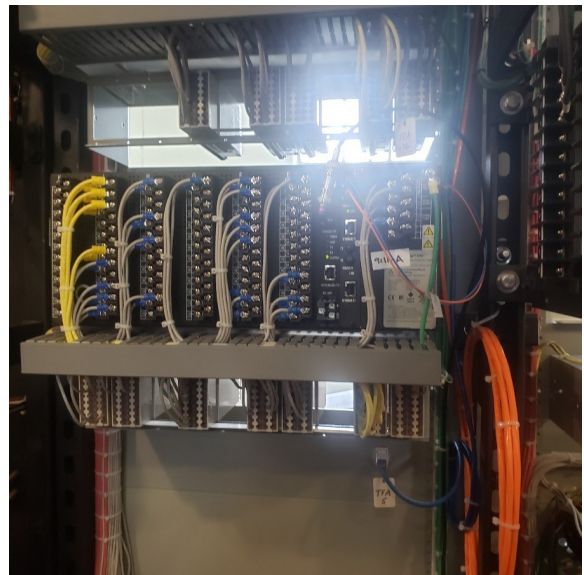
- To locate the source of the AC coupling, the team placed the receiver in its 50/60 Hz AC mode, a unique ability of the MGFL100. We were then able to trace the 60 Hz current to its source, which was the battery charger. This is why the other tracers failed to locate the real fault. The team isolated the battery charger from the system to remove the AC.
- We turned the transmitter back on and could now measure the fault current on the negative buss.
- The receiver was then placed back into the normal low frequency tracing mode, and the real fault was traced to a relay. The team removed the ground lead from the relay, and the ground fault vanished.
