## DC ground fault locating under difficult conditions An AC coupling tale...

## DC ground fault locating in the presence of unwanted AC coupling

Tennessee Valley Authority (TVA), located in the Southeastern region of the United States, generously supplied this case study.

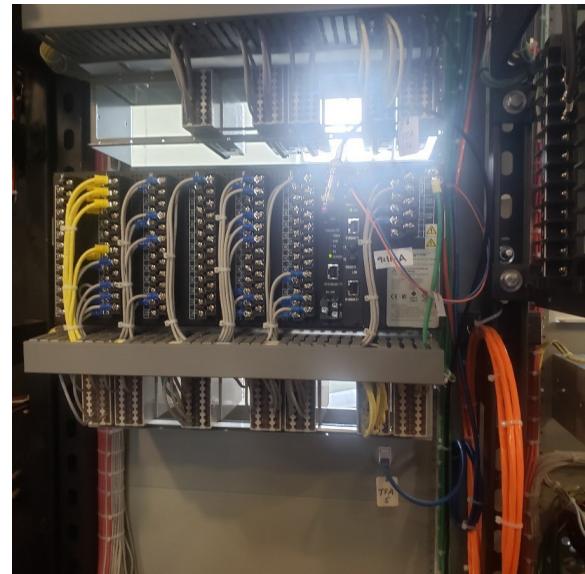
- To locate the source of the AC coupling, the team placed the receiver in its 50/60 Hz AC mode, a unique ability of the MGFL100. We were then able to trace the 60 Hz current to its source, which was the battery charger. This is why the other tracers failed to locate the real fault. The team isolated the battery charger from the system to remove the AC.
- We turned the transmitter back on and could now measure the fault current on the negative buss.
- The receiver was then placed back into the normal low frequency tracing mode, and the real fault was traced to a relay. The team removed the ground lead from the relay, and the ground fault vanished.

- What complicated the ground fault tracing in this case was the presence of an AC current that was coupling over to the DC system.
- The MGFL100 transmitter will fluctuate in the presence of low-frequency AC current. Since an operator can place the MGFL100 receiver in a 50/60Hz mode, it allows the operator to trace stray AC current that may be present on a DC system. So, not only did the operator locate the real ground fault in the relay, but they also discovered a wiring issue in the charger that was coupling AC onto the DC system.

- TVA located the real ground fault in the relay, eliminating the alarm in the substation. Plus, they identified a wiring issue in the battery charger that was coupling AC onto the DC system, which could cause further damage and degradation of the DC system.
