SONAVU+

THE NEXT GENERATION OF ACOUSTIC IMAGING

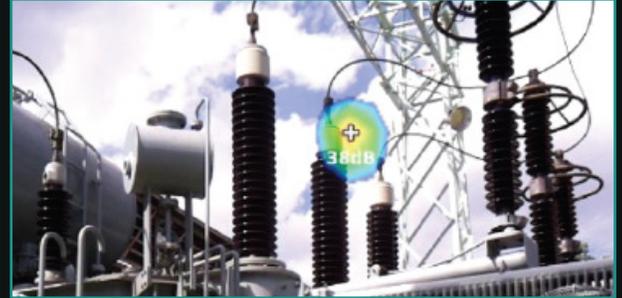
ELECTRICAL SYSTEM RELIABILITY

Issues like arcing, tracking, and corona discharge generate high-frequency sound, often undetectable by the human ear. Acoustic imaging inspection makes these faults visible, allowing maintenance teams to pinpoint and address them before they escalate.

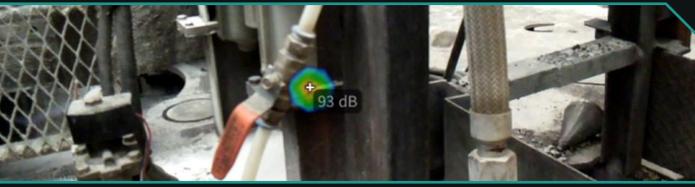
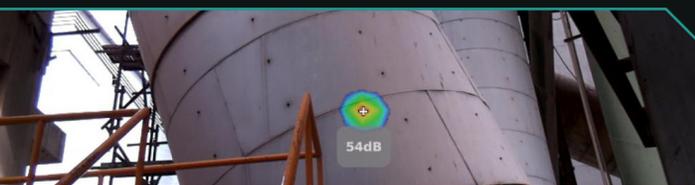
LEAK DETECTION

Acoustic imaging makes locating and visualizing leaks in real time easy... Even in noisy environments. When leaks are identified promptly, energy costs go down, system efficiency goes up, and compressed lifespan is extended.

Fugitive emissions threaten safety and compliance. But locating them is challenging due to low pressures and hazardous environments. SonaVu+ delivers sensitivity, range, and ATEX availability for safe, reliable inspections.

Vacuum leaks create system inefficiencies, energy waste, and can potentially damage products and equipment. Acoustic imaging is a fast and reliable way to locate these leaks by visualizing the high frequency sounds they produce.
